PRELIMINARY REPORT 1 JUNE 2016

ACCIDENT AT TURØY, NEAR BERGEN, NORWAY ON 29 APRIL 2016, INVOLVING AIRBUS HELICOPTERS H225, LN-OJF OPERATED BY CHC HELIKOPTER SERVICE AS

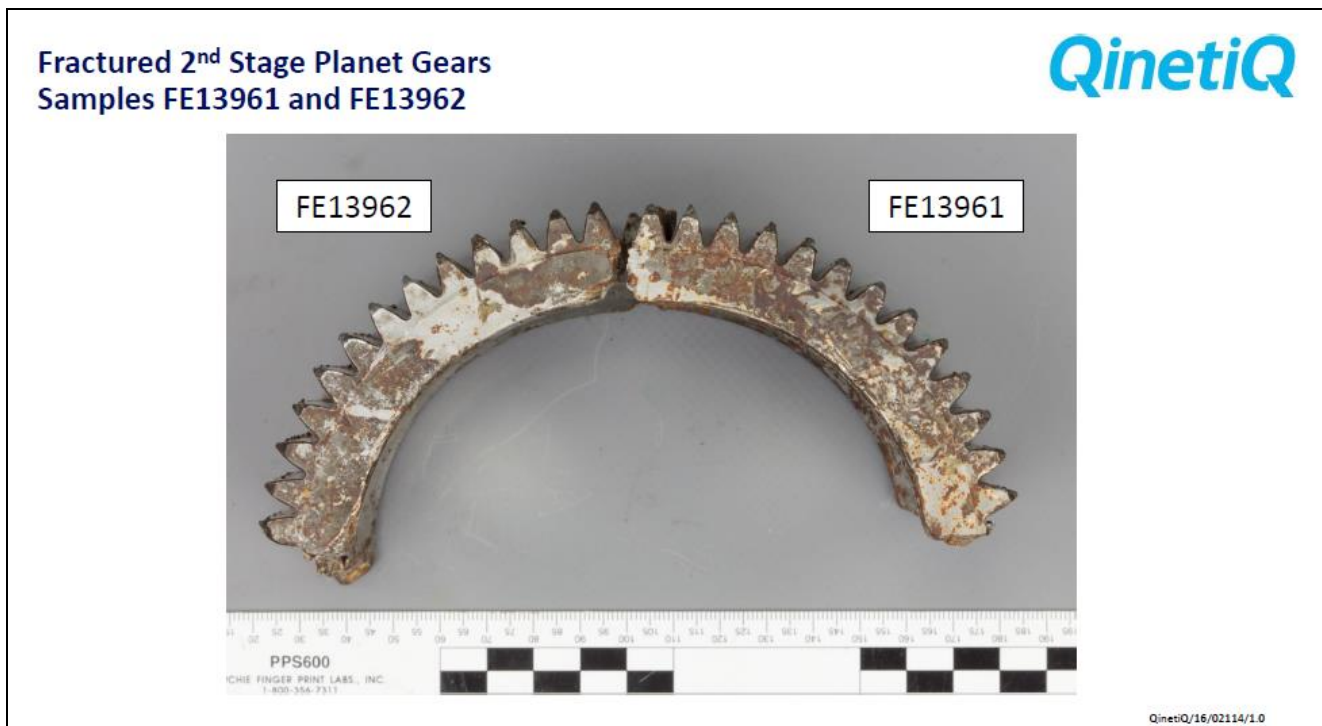
Among the recovered parts were two pieces which together form approximately half a second stage planet gear (ref. Figure 2). Examinations of these parts have revealed features strongly consistent with fatigue. The fatigue appears to have its origin in the outer race of the bearing (inside of the gear), propagating towards the web of the gear teeth. There is sign of spalling in front of the fracture surface.

Figure 2: The two pieces of the second stage planet gear prepared for metallurgical examinations.
Photo: QinetiQ

Recent metallurgical findings have revealed features strongly consistent with fatigue in the outer race of a second stage planet gear in the epicyclic module of the MGB. It cannot be ruled out that this signifies a possible safety issue that can affect other MGBs of the same type. The nature of the catastrophic failure of the LN-OJF main rotor system indicates that the current means to detect a failure in advance are not effective.

The AIBN therefore recommends that EASA take immediate action to ensure the safety of the Airbus Helicopters H225 Main Gear Box.
