ACCIDENTS INVESTIGATION BRANCH.

Precis Number:	Date of Accident:	Aircraft:	Unit:
W-1086a.	15.8.41.	Liberator A.M.261.	R.A.F.Ferry Command.

Service Accident Report No. W-1086A.

AIRCRAFT: Consolidated LB.30A  
Liberator A.M.261.

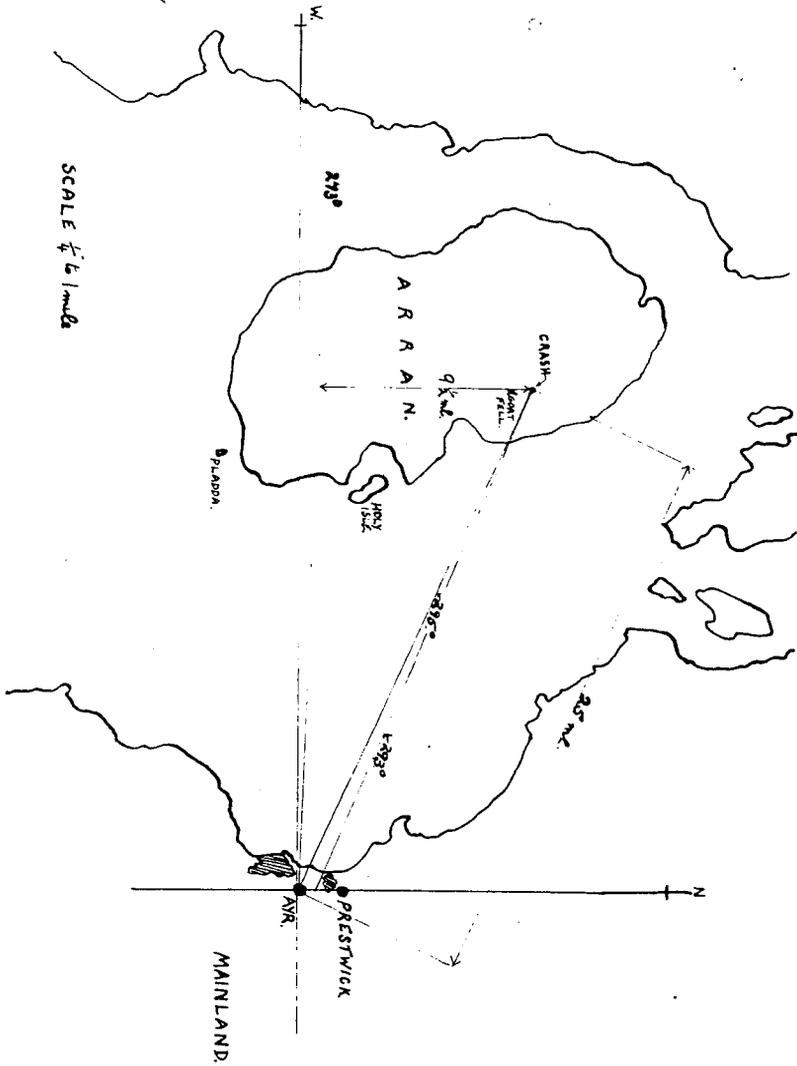
The aircraft had crashed into the southern slope of an Bhinnean about 75 ft. below the summit (approx. 2,700 ft above sea level) and near the western extremity of the ridge. This hill forms the north side of Corrie Glen, the south side being bounded by Goat Fell the highest mountain on the island. The valley between runs almost N.W. and S.E. and a line from the crash to Ayr runs diagonally across it, missing the peak of Goat Fell by a narrow margin.

The direct track from Ayr aerodrome to the crash is 295° and assuming that the aircraft was about 1 mile north of the aerodrome on its circuit the track would be 293°. The track to be made, as given in the 'Flight Plan' was 273°. A scale map of the area involved is attached showing the tracks mentioned.
